**MANDATORY****MTL-30-01****TITLE**

ICE AND RAIN PROTECTION - INERTIAL VANE CONTROL JOURNAL VERIFICATION

<b>MODEL</b>	<b>SERIAL NUMBERS</b>
King Air B300	FL-1079 thru FL-1089, FL-1091 thru FL-1100
King Air B300C	FM-71

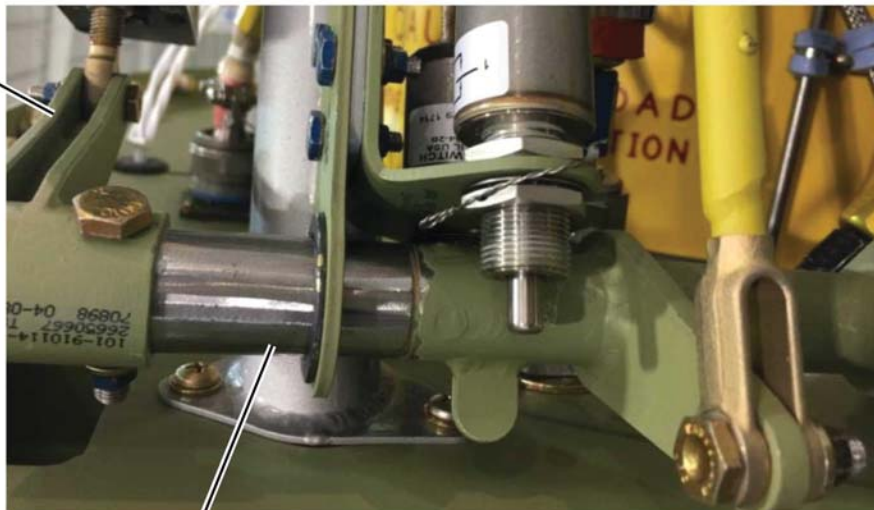
The bushings in the 101-910114-13 and 101-910114-135 Levers in the anti-ice control shaft assembly were not built to specifications on some units. When assembled the 101-910114-75 and 101-910114-77 Journals were ground down to fit. This removed the cad plating and paint protecting the steel rod. The absence of this protection exposes the journal rod ends to corrosion and potential failure of the anti-ice system.

Cad Plating Removed

3. (Refer to Figure 1, Detail B and Figure 2.) Do an inspection of the forward shaft assembly.
  - A. If the journal shows indications of being ground down, go to Step 4.

- B. If the journal does not show any indication of being ground down, go to Step 10.
4. Remove the forward shaft assembly. (Refer to Beechcraft B300/B300C Fusion Maintenance Manual, Chapter 30, Ice and Rain Protection - Forward (No. 1) Vane Assembly - Removal/Installation.)

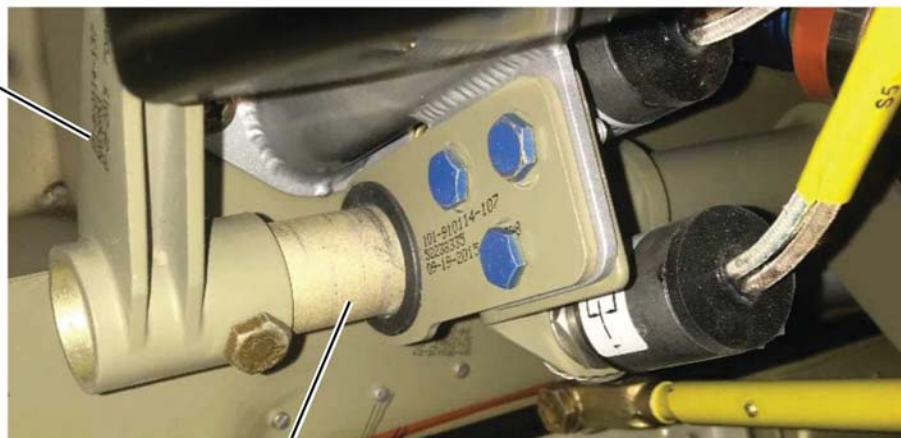
With Cad Plating
