MANDATORY**SEL-57-05****TITLE**

WINGS - BONANZA STALL STRIP RELOCATION

Bonanza G36

E-4110 thru E-4112

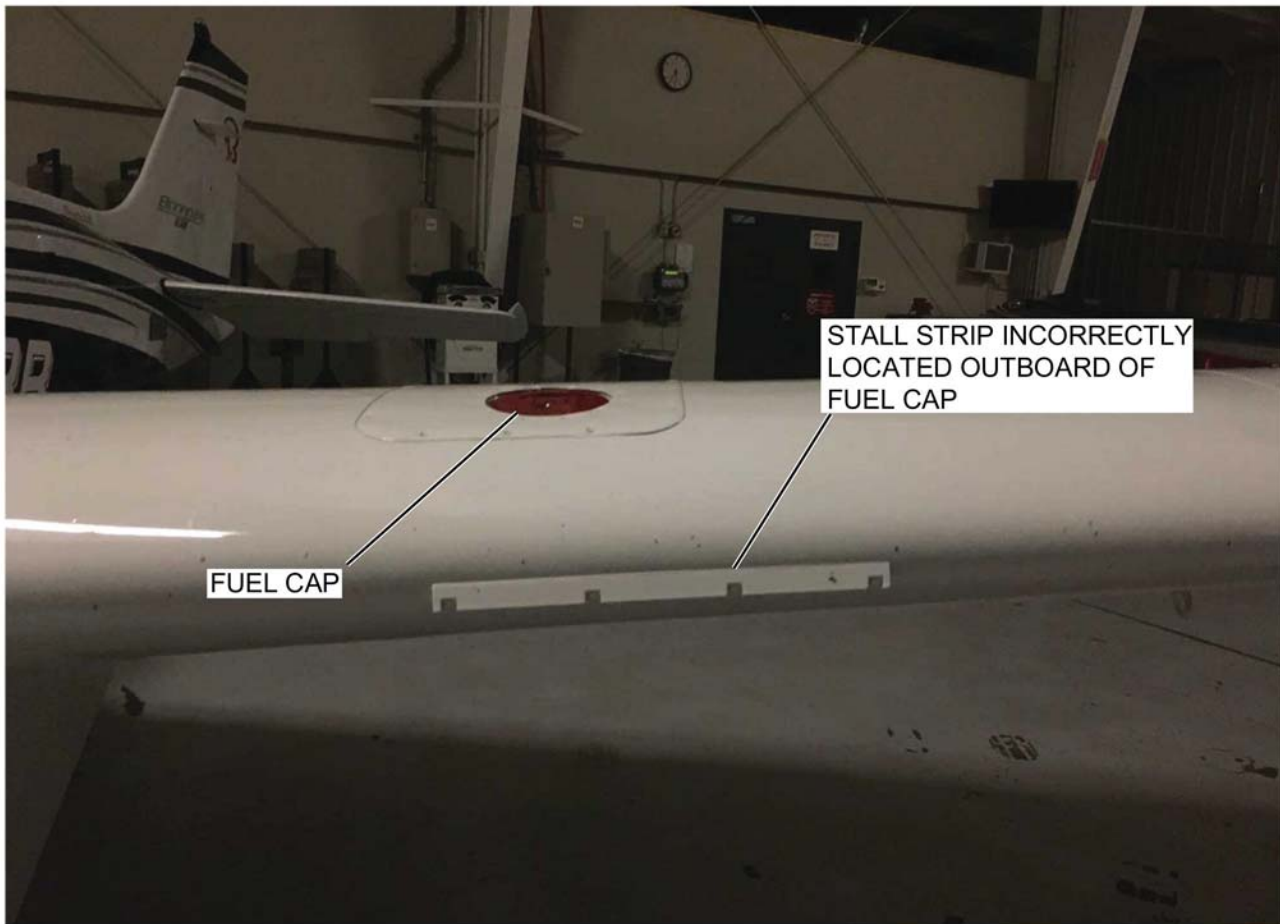
Figure 1. Bonanza Stall Strip Relocation (Sheet 1)

1. (Refer to Figure 1, Sheet 1 and Sheet 2.) Inspect to determine if the left hand stall strip is installed outboard of the fuel cap.
 - A. If the stall strip is outboard of the fuel cap, it must be relocated. Go to Step 2.

- B. If the stall strip is correctly installed inboard of the fuel cap, no further action is required. Go to Step 6.
2. Prepare the airplane for maintenance.
