# Multi-Engine Turboprop Communiqué

Communiqué ME-TP-0024  
January 2021

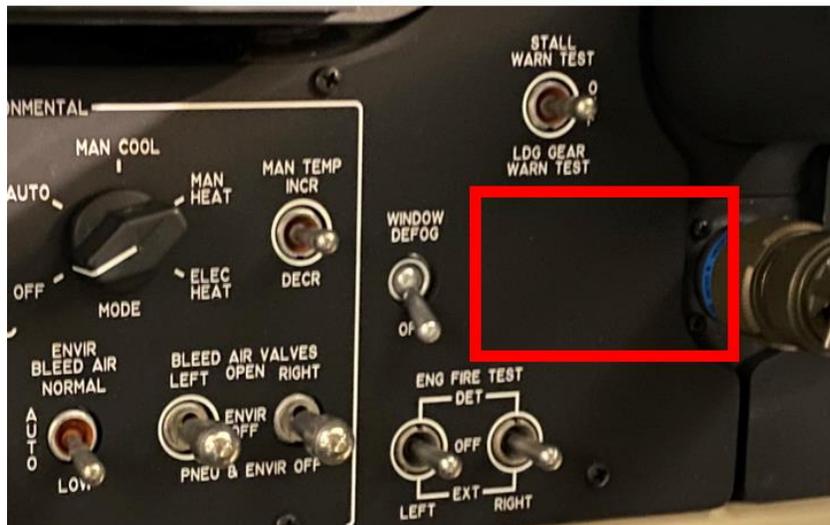
King Air 360 with 7 psi Max Cabin Differential

With the introduction of the eKAPS II digital pressurization system at FL-1201, FL-1234 and after and FM-98 and after, Textron Aviation offers operators the choice of an aircraft to have either a 6.5 psi or 7.0 psi max cabin differential cabin. The easiest way to differentiate the 6.5 aircraft from the 7.0 aircraft are the CABIN ALT WARN switch or lack thereof. The 7.0 aircraft have both CABIN ALT WARN switch removed (see location in 7 psi photo). This switch was installed in the B300 prior to the eKAPS II system. The 6.5 eKAPS II aircraft will remove the test switch, but the silence switch will remain (see location in 6.5 psi photo).

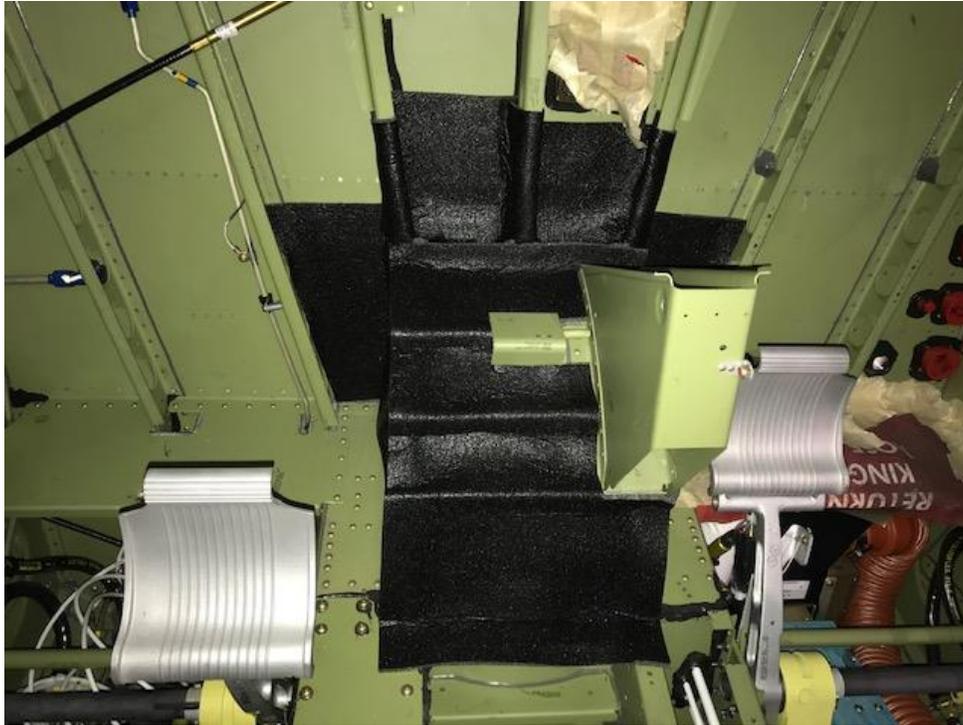
The black insulation and acoustical material used just forward of the pedestal between the rudder pedals is part number 101-531057-601. This part number will provide a sheet which is then cut to fit the area as shown in the picture below.

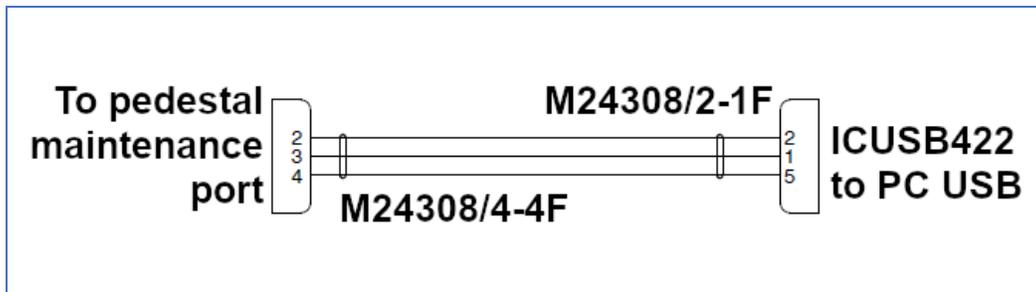
This cable connects to the pedestal maintenance port 3456J2 shown in WDM 34-25-01.

Textron Aviation has a cable available for this interface, part number PR00145715, or a harness can be fabricated as follows:

- 1) USB to serial adapter, ICUSB422 or equivalent. Set DIP switch 1 to the RS-485 setting;
- 2) M24308/2-1F or equivalent 9-pin dsub plug with socket contacts;
- 3) M24308/4-4F or equivalent 37-pin dsub jack with pin contacts; and
- 4) Approx. 6 feet of 22 gage wire, twisted shielded if available.
