**MANDATORY****MTL-30-01****TITLE**

ICE AND RAIN PROTECTION - INERTIAL VANE CONTROL JOURNAL VERIFICATION

<b>MODEL</b>	<b>SERIAL NUMBERS</b>
King Air B300	FL-1079 thru FL-1089, FL-1091 thru FL-1100
King Air B300C	FM-71

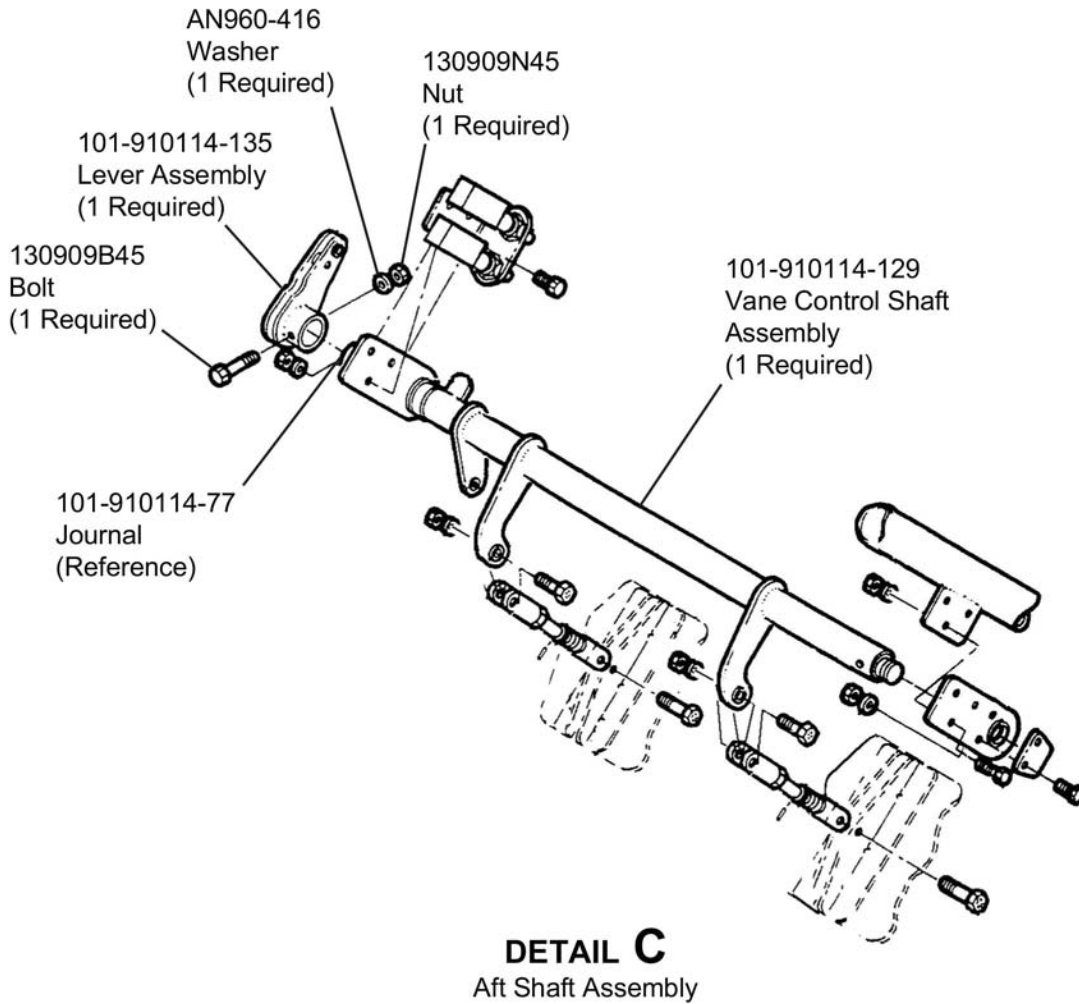
Figure 1. Forward and Aft Vane Assemblies (Sheet 2)

The bushings in the 101-910114-13 and 101-910114-135 Levers in the anti-ice control shaft assembly were not built to specifications on some units. When assembled the 101-910114-75 and 101-910114-77 Journals were ground down to fit. This removed the cad plating and paint protecting the steel rod. The absence of this protection exposes the journal rod ends to corrosion and potential failure of the anti-ice system.

3. (Refer to Figure 1, Detail B and Figure 2.) Do an inspection of the forward shaft assembly.
  - A. If the journal shows indications of being ground down, go to Step 4.

- 11. (Refer to Figure 1, Detail C and Figure 2.) Do an inspection of the aft shaft assembly.
  - A. If the journal shows indications of being ground down, go to Step 12.

7. Remove the existing 101-910114-71 forward weld assembly from the forward shaft assembly. Keep the noted attachment hardware.
8. Use kept attachment hardware to install one new 101-910114-71 Forward Weld Assembly onto the forward shaft assembly.

- 15. Remove the existing 101-910114-129 vane control shaft assembly from the aft shaft assembly. Keep the noted attachment hardware.
- 16. Use kept attachment hardware to install one new 101-910114-129 Vane Control Shaft Assembly onto the aft shaft assembly.
